CASE STUDY | AUGUST 2021

**POTATO LINK**  
AUSTRALIAN POTATO INDUSTRY  
EXTENSION PROJECT

# IRRIGATION SCHEDULING WITH IrriSAT

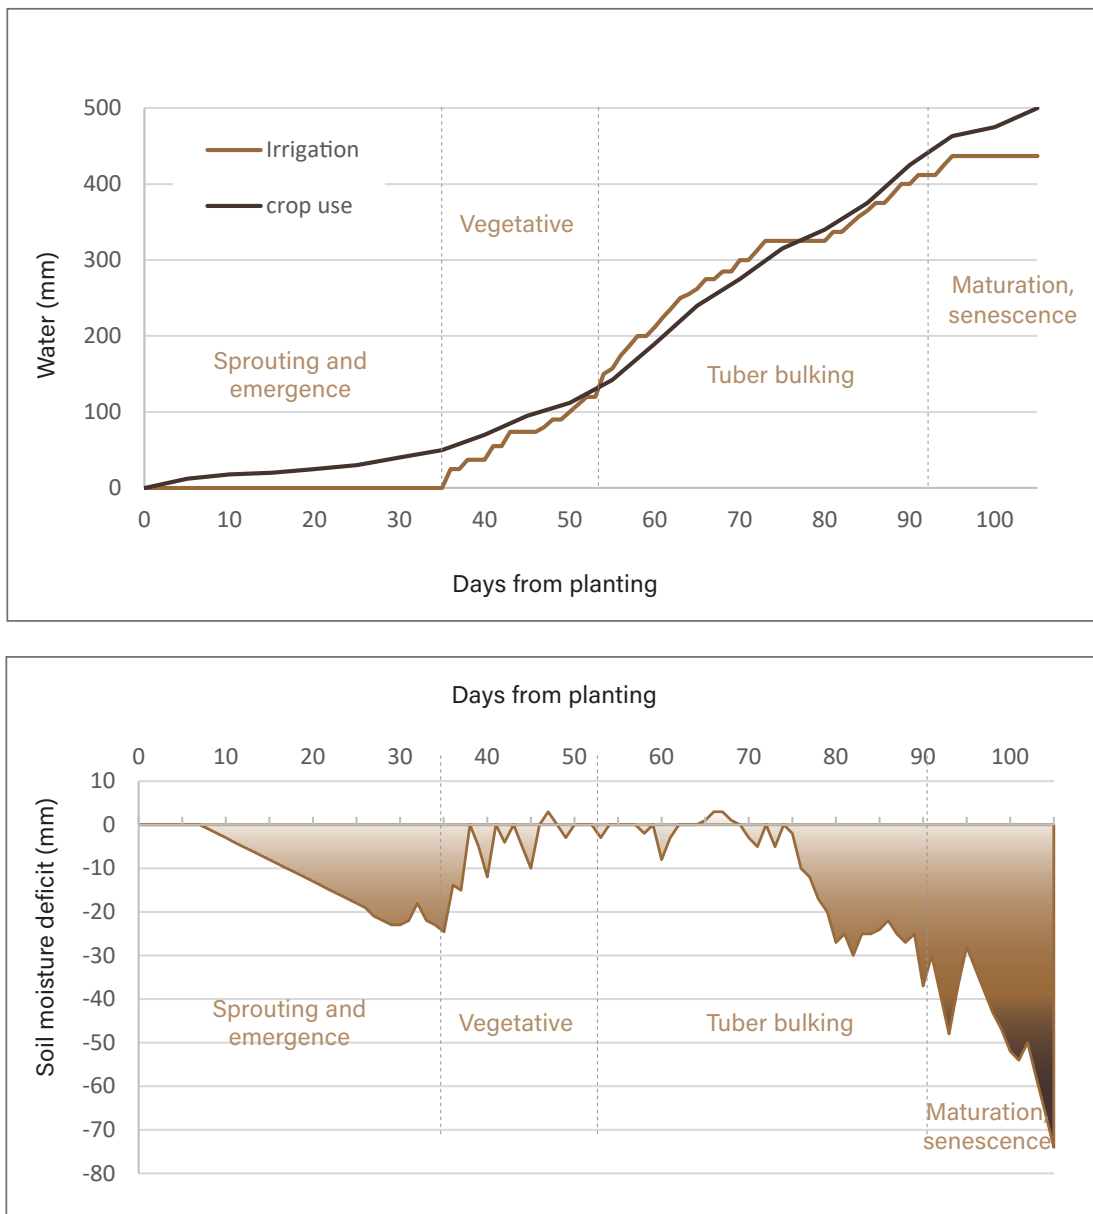
**Figure 1.** Irrigation applied combined with IrriSAT estimate of moisture requirements of the crop (top) and moisture deficit in the soil (bottom)

The data from IrriSAT demonstrates how water use by the crop changed during maturation (Figure 1). In this case, the grower generally matched demand well with irrigation.

However, a delay in re-starting irrigation after 9mm rain meant the crop entered the rapidly growing vegetative stage with a significant soil moisture deficit.

To overcome this deficit, the grower ran the pivot hard to refill the soil and keep up with crop development. This got the crop back on track in time for the tuber bulking stage.

A second, larger fall of rain some weeks later (mid-January) filled the soil to capacity. In this case, irrigation was not restarted for 7 days. Again, the moisture deficit increased, as strong demand by the crop combined with high daily temperatures (>35°C) reduced soil moisture below 10% VWC.

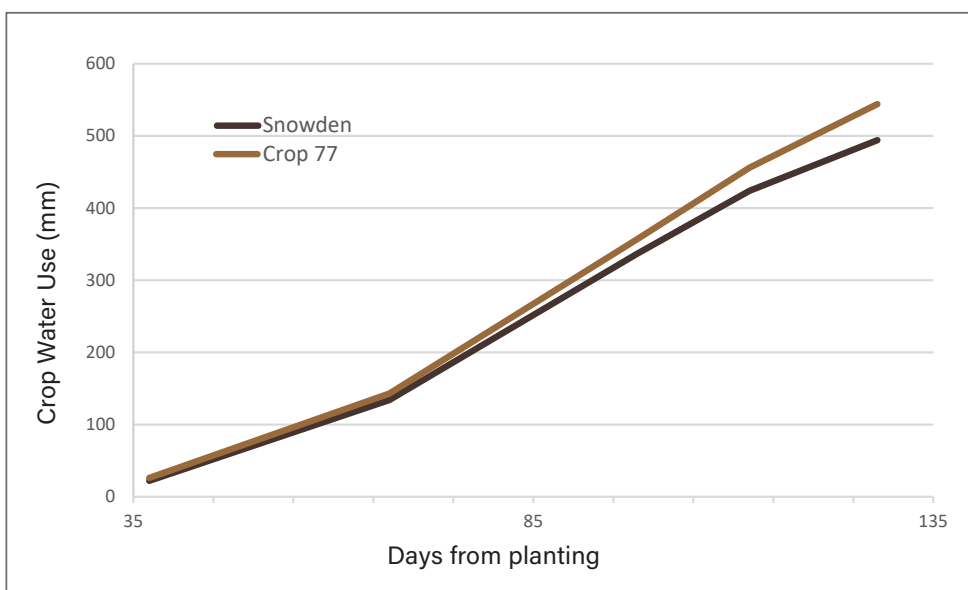
**Figure 2.** The IrriSAT image of a pivot planted with two different potato varieties clearly shows the difference in canopy coverage (top); this information can be used to estimate the irrigation requirement of each variety (bottom).

In another study, potato varieties cv. ‘Snowden’ and ‘Crop 77’ were grown under a single pivot. Crop 77 is an indeterminate variety with a large, deep root system. As a result, it can access water from a deeper soil profile than the more determinate, shallow rooted Snowden. As evident from Figure 2, canopy coverage increased estimated crop water use in Crop 77 relative to Snowden.

As the IrriSAT system measures canopy coverage, it could estimate the differing irrigation needs of each variety. While in this case it was not possible to adjust irrigation precisely to the needs of each variety, it may be useful to consider this when planting future crops.

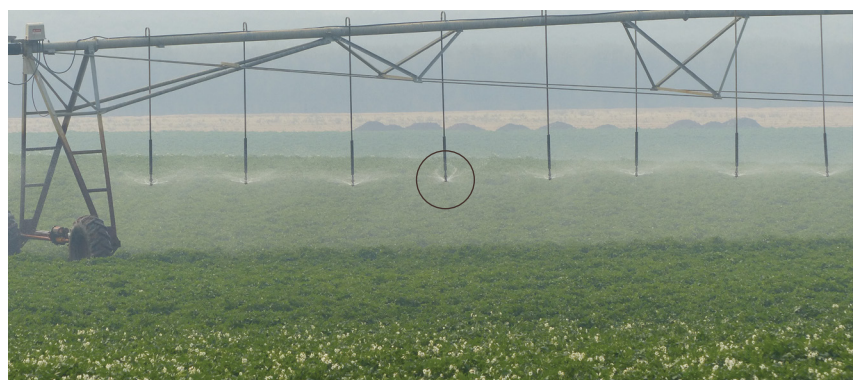
**Figure 4.** A faulty sprinkler head; for this crop, which was grown during hot weather, reduced irrigation limited growth and caused an estimated 10% drop in yield.

It was estimated that the issue with the two faulty sprinkler heads reduced the yield in a 3.1 ha zone by 17 tonnes, costing the grower between \$4,800 – \$6,800. Early identification of this issue using IrriSAT could have prevented this occurring.
